SUBJ: RCRA Compliance Evaluation Inspection
Orchid Orthopedic Solutions Alabama, LLC
EPA ID Number: ALD063671093

RCRA Inspection Report

Orchid Orthopedic Solutions Alabama, LLC
331 City Park Drive SE
Arab, Alabama 35016
Sumter County
EPA ID: ALD063671093

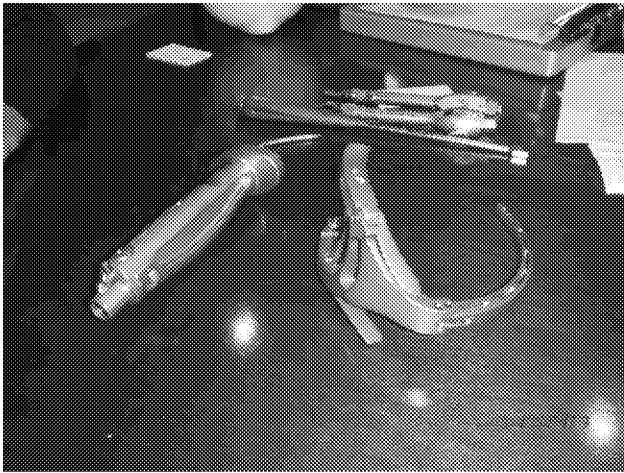
Orchid Orthopedic Solutions Alabama, LLC, (Orchid) in Arab, Alabama, specializes in the manufacturing of orthopedic instruments and implant medical devices (Picture 1). The manufactured parts are composed of metals such as stainless steel or titanium. Orchid operates many different lines to produce devices with custom finish required for their customers' specifications.

Picture [SEQ Picture * ARABIC] – Final Products

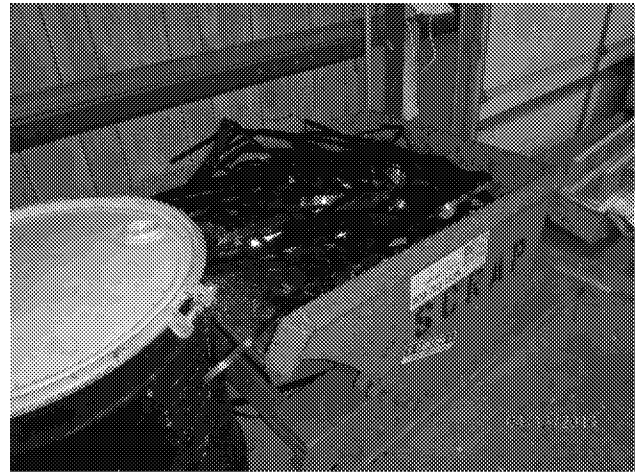
The Saw Room is used to store the incoming raw material. The inspectors observed a 55-gallon drum of titanium chips to be recycled (Picture 2) and a blue hopper with scrap wire and metal for recycling (Picture 3). Mr. Baldwin stated that the recycled titanium would be sent to Sharpiro Metals, and the spent machine coolant would be recycled by Holcim. No hazardous waste was observed in this area.

Picture [SEQ Picture * ARABIC] – Saw Room scrap metal hopper

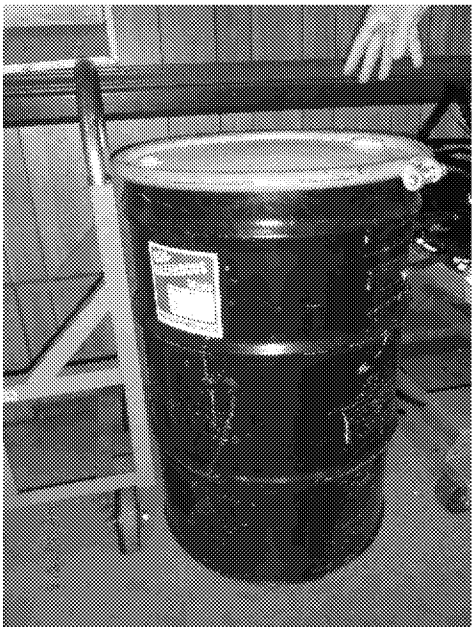
Picture [SEQ Picture * ARABIC] – Saw Room titanium chips for recycle

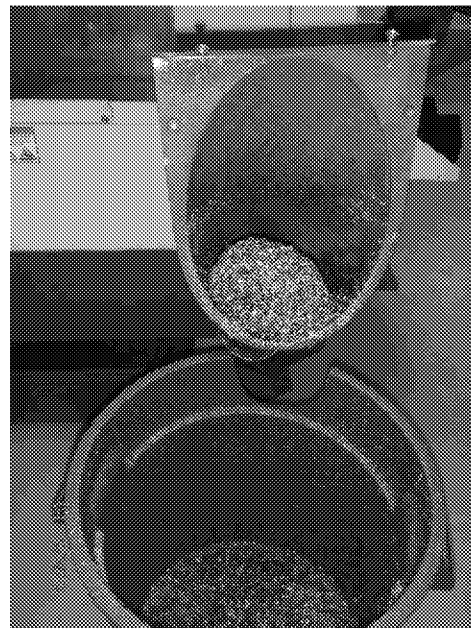
Picture [SEQ Picture * ARABIC] – Building A shavings/chips

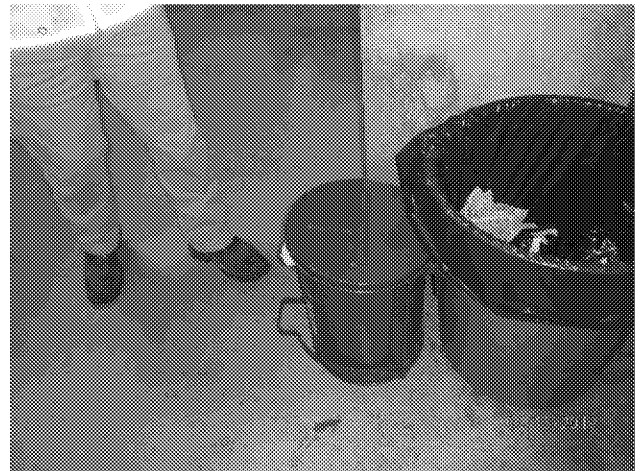
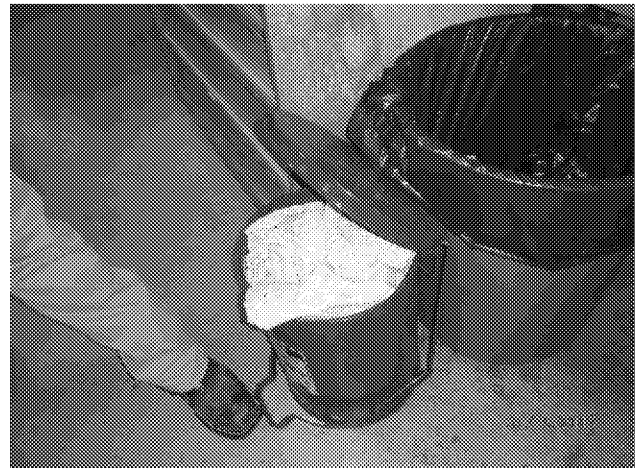
Picture [SEQ Picture * ARABIC] – Building A spent alcohol rags

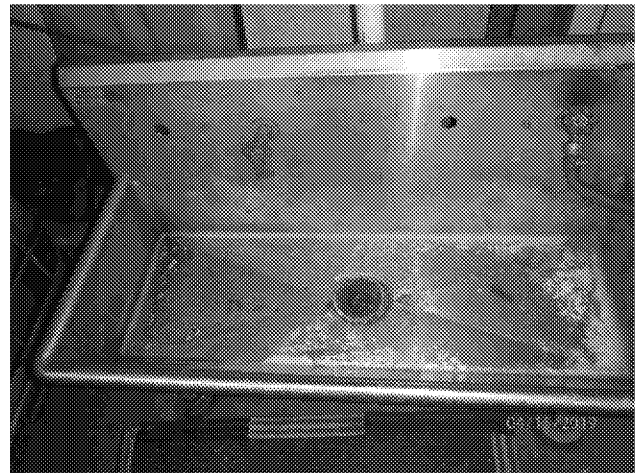
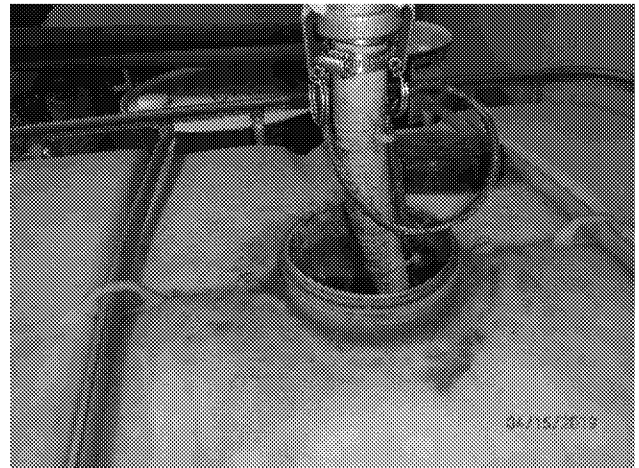
The Shipping and Receiving Dock receives the incoming raw material, stores the fuel and oil used in the facility and houses the mop station. Mr. Hawkins explained that the mop water is discarded in the mop station sink. The mop water contains spent Qualichem, a blue coolant oil used in the machinery. The inspectors observed that piping from the mop stations discharges into an open 250-gallon tote labeled "Used Mop Water" (Pictures 12-14). Holston Environmental pumps and ships out the oily water with a vacuum truck every two months. The inspectors explained to Mr. Hawkins because the mop water contains spent Qualichem, the tote should be labeled as used oil, not used mop water.

Picture [SEQ Picture * ARABIC] – Shipping/Receiving Dock mop station and oily water tank

Picture [SEQ Picture * ARABIC] – Shipping/Receiving Dock mop station

Picture [SEQ Picture * ARABIC] – Shipping/Receiving Dock oily water tank open

Pursuant to ADEM Admin. Code r. 335-14-17-.03(4)(c)1. [40 C.F.R. § 279.22(c)(1)], containers and aboveground tanks used to store used oil at generator facilities must be labeled or marked clearly with the words "Used Oil."

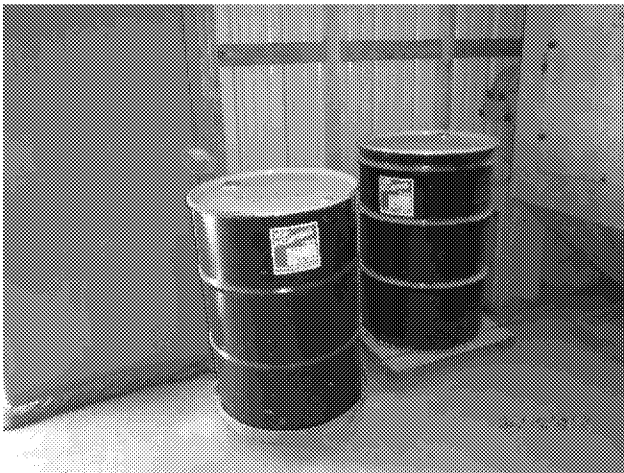
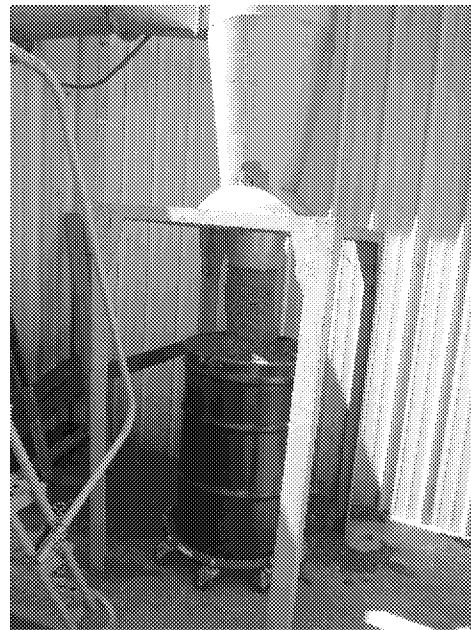
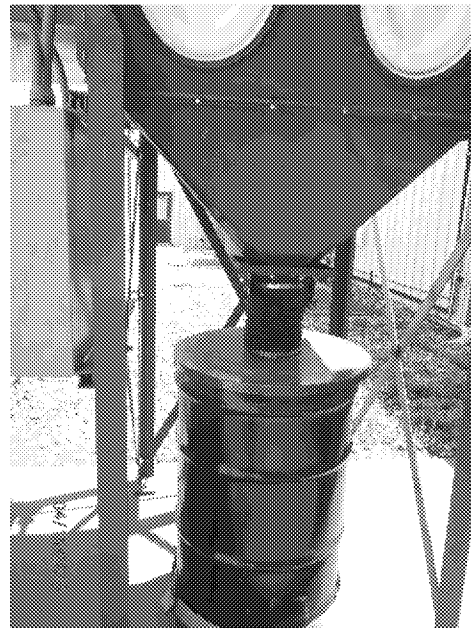
The Dust Collection Room is a locked room that contains the spent bead blast drums (Picture 16). Outside the room is the bead blast hoppers and the Scotch Brite hoppers (Pictures 17-18). The spent bead blast and the Scotch Brite pink fluff dust is determined by the facility to be non-hazardous.

Picture [SEQ Picture * ARABIC] – Bead Blast Hopper used bead media drums

Picture [SEQ Picture * ARABIC] – Bead Blast Hopper Scotch Brite waste drums

Picture [SEQ Picture * ARABIC] – Bead Blast Hopper used bead media waste drum

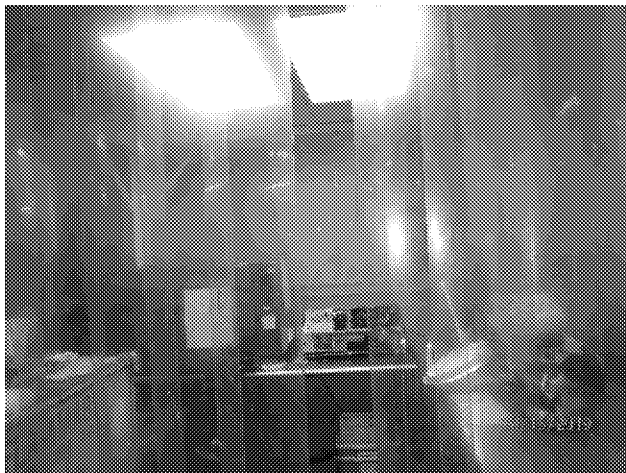
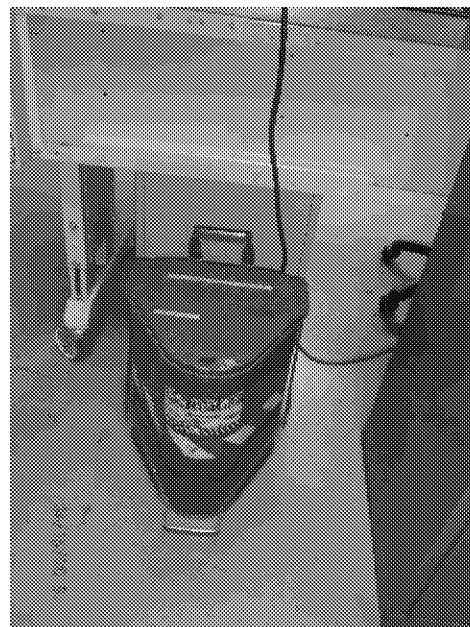
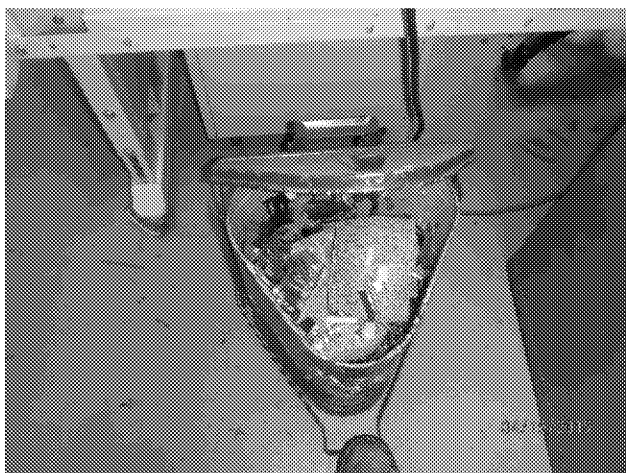
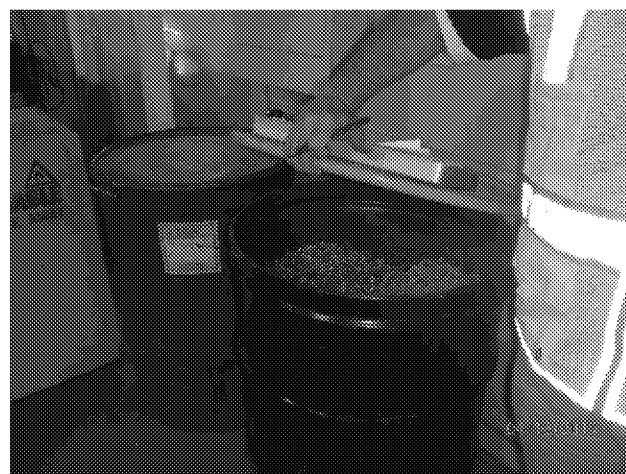
Building B manufactures a low volume and a high mixture of random parts. Painting and electroplating occur in this building. The inspectors observed the paint booth, a 5-gallon red step can with waste paint debris that was not labeled, a 55-gallon drum of waste paint debris and a 55-gallon drum of aluminum chips (Pictures 19-23). Mr. Hawkins explained that the contents of the step can are transferred to the SAA drum. The inspectors stated that the step can must be labeled and must be emptied at the end of every shift.

Picture [SEQ Picture * ARABIC] – Building B Paint Booth

Picture [SEQ Picture * ARABIC] – Building B Paint Booth small step can SAA

Picture [SEQ Picture * ARABIC] – Building B Paint Booth SAA drums

Picture [SEQ Picture * ARABIC] – Building B Paint Booth paint debris SAA

Pursuant to ADEM Admin. Code r. 335-14-3-.01(5)(a)5. [40 C.F.R. § 262.15(a)(5)], which is a condition of the SAA Permit Exemption, a generator is required to mark or label its containers (i) with the words "Hazardous Waste" and (ii) with an indication of the hazards of the contents.

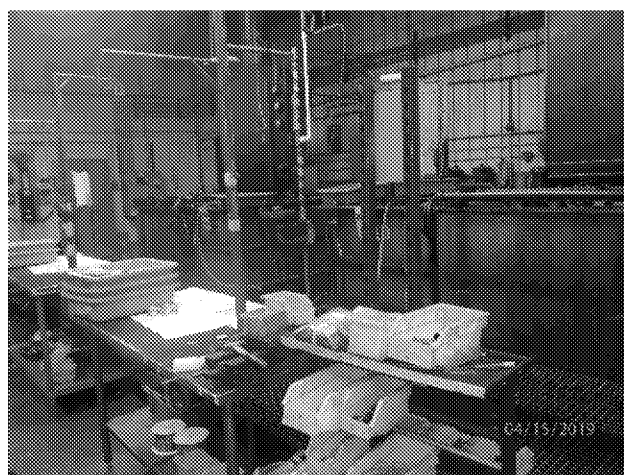
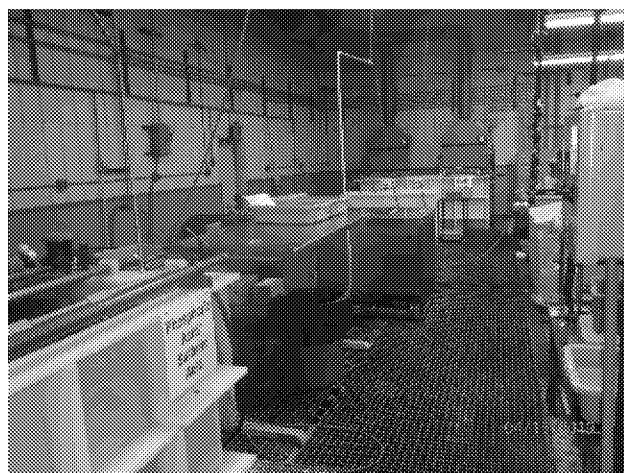
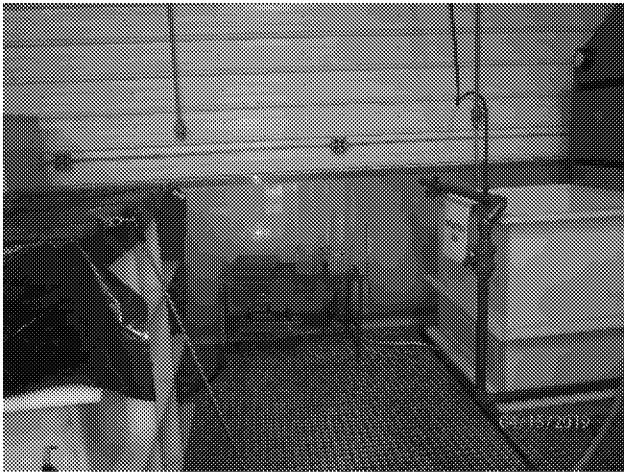
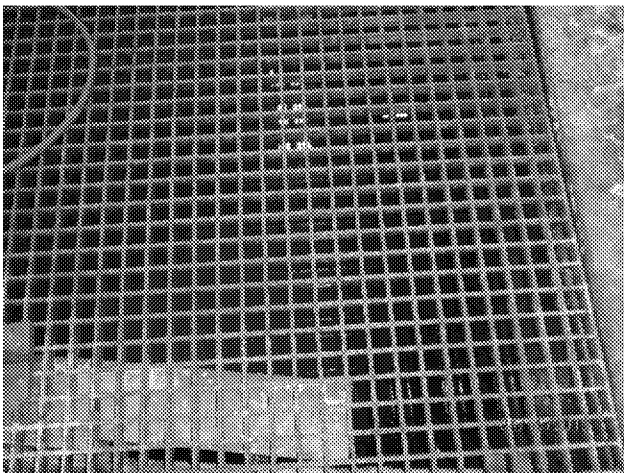
The Electroplating Area is an enclosed room containing tanks for chromic acid, sulfuric/phosphoric acid, citric acid, sodium hydroxide, hydrochloric acid and water rinse tanks (Pictures 24-33). Mr. Hawkins introduced Mr. Chris Smith and Mr. Andrew Jung, the electroplating technicians and the hazardous waste handlers, and explained that the sulfuric/phosphoric acid wastes are constantly being pumped out and generated the bulk of the hazardous waste being shipped from the facility. Pump out generates two 55-gallon drums of acid waste. Sulfuric/phosphoric acid and rinse water was observed in the secondary containment (Picture 29).

Picture [SEQ Picture * ARABIC] – Electroplating

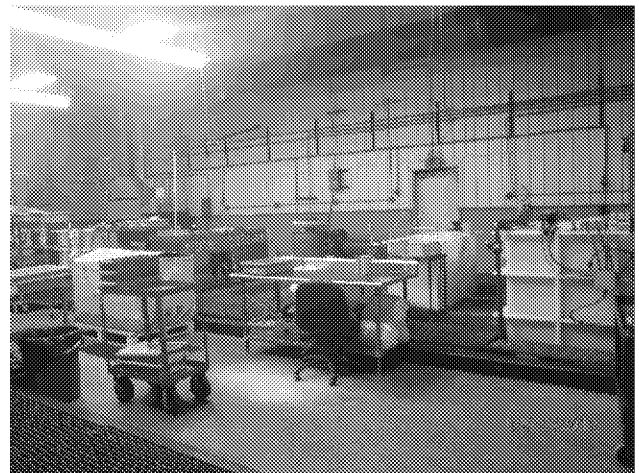
The inspectors observed that all the tanks sat on a single secondary containment area. Any releases from the acid and rinse tanks went to the secondary containment and was subject to comingling. At the time of the inspection, the inspectors observed that underneath the chromic acid and rinse tanks was chromic acid sludge that had been stored inside the grated secondary containment for over a year (Pictures 24-25). The chromic acid sludge was observed dried and cracked (Pictures 30, 33). The inspectors stated that the chromic acid sludge was being stored in the secondary containment and had not been immediately cleaned out after a release. Thus, the secondary containment was considered a hazardous waste tank storage.

Picture [SEQ Picture * ARABIC] – Electroplating secondary containment

Picture [SEQ Picture * ARABIC] – Electroplating
secondary containment

Pursuant to ADEM Admin. Code r. 335-14-3-.01(7)(a)2. [40 C.F.R. § 262.17(a)(2)], which incorporates ADEM Admin. Code r. 335-14-6-.10 [40 C.F.R. Part 265, Subpart J], and is a condition of the LQG Permit Exemption, a generator accumulating hazardous waste in tank systems is required to comply with the applicable requirements of ADEM Admin. Code r. 335-14-6-.10 [40 C.F.R. Part 265, Subpart J], except ADEM Admin. Code r. 335-14-6-.10(8) [40 C.F.R § 265.197(c)] (closure and post-closure care) and ADEM Admin. Code r. 335-14-6-.10(11) [40 C.F.R § 265.200] (waste analysis and trial tests).

Pursuant to ADEM Admin. Code r. 335-14-3-.01(7)(a)5.(ii) [40 C.F.R. § 262.17(a)(5)(ii)], which is a condition of the LQG Permit Exemption, a generator must mark or label its tanks with the words “Hazardous Waste”; mark or label its tanks with an indication of the hazards of the contents; use inventory logs, monitoring equipment or other records to demonstrate that hazardous waste has been emptied within 90 days of first entering the tank; and keep inventory logs or records with the above information on site and readily available for inspection.

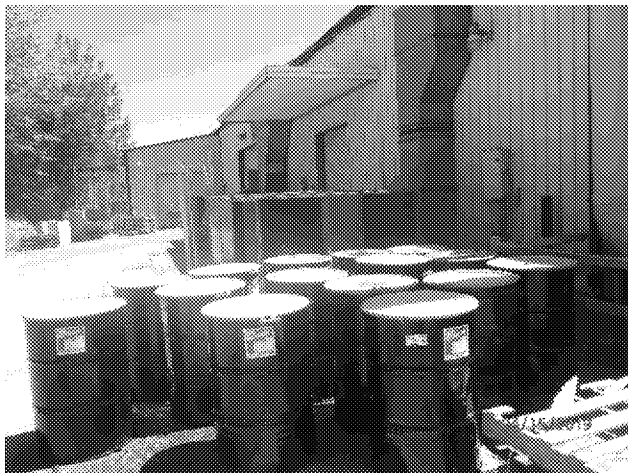
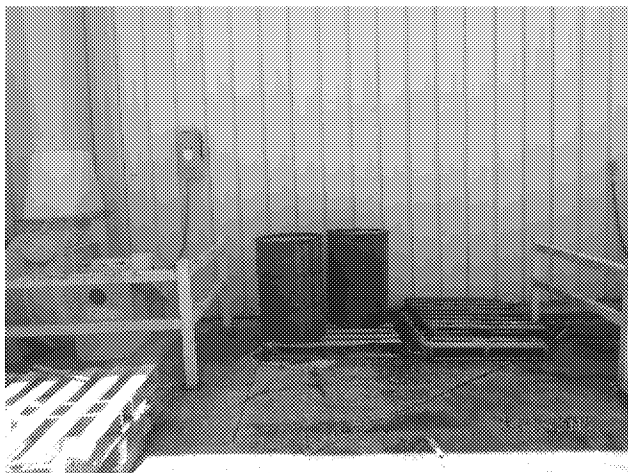
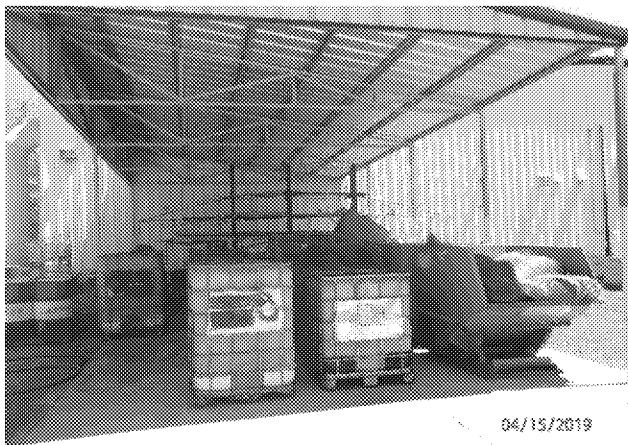
The inspectors toured the outside non-hazardous waste storage area. The inspectors observed thirteen 55-gallon drums of titanium waste for recycling, two rusted 55-gallon drums of spent tumbler media and six empty coolant totes (Pictures 34-36). No hazardous waste was observed in this area.

Picture [SEQ Picture * ARABIC] – Outside Non HW Storage titanium waste drums

Picture [SEQ Picture * ARABIC] – Outside Non HW Storage tumbler media waste

Picture [SEQ Picture * ARABIC] – Outside Non HW Storage empty coolant totes

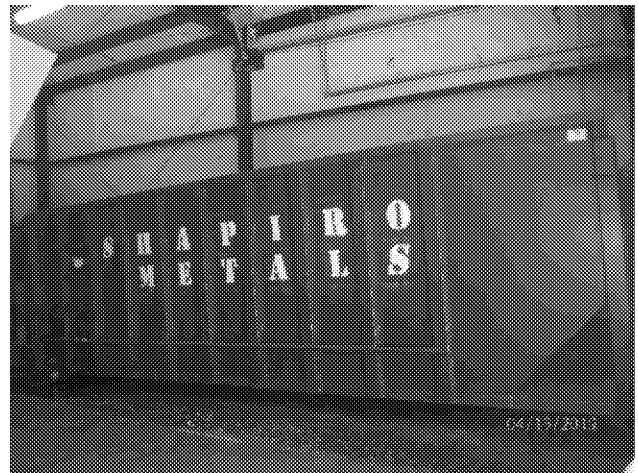
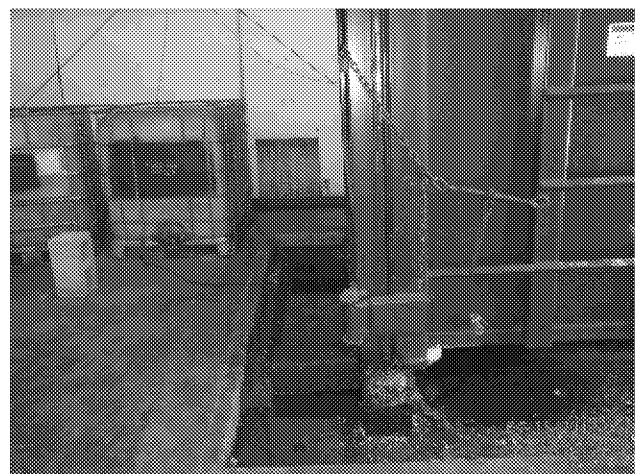
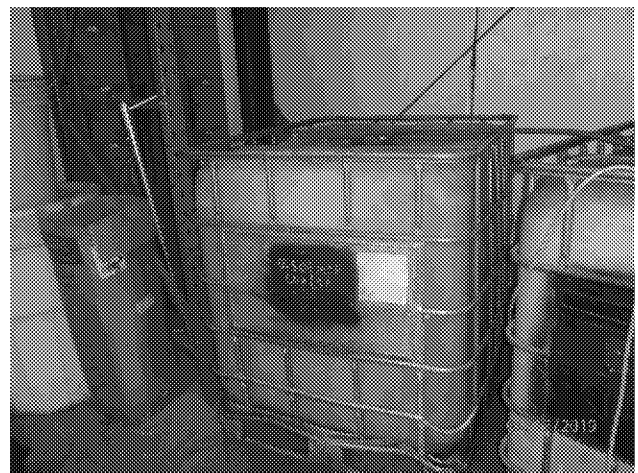
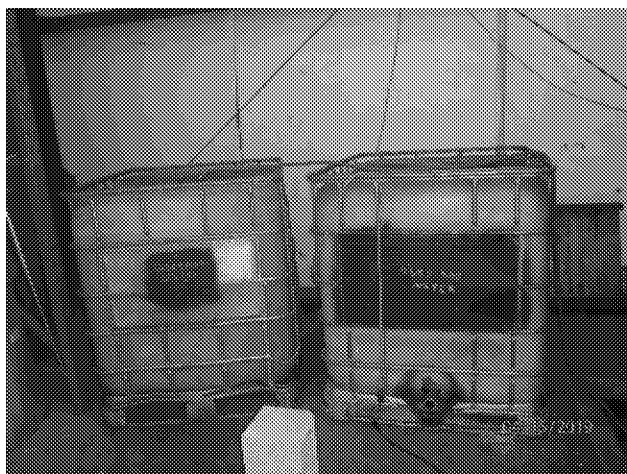
The Chip Shed contained a 20-cubic yard roll-off of metal shavings and chips to be recycled (Picture 37). The shavings and chips are dumped into the roll-off and the spent coolant drains off the chips into the secondary containment (Picture 38). The oily water is then pumped into totes marked as “Used Mop Water” (Picture 39).

Picture [SEQ Picture * ARABIC] – Chip Shed roll-off

Picture [SEQ Picture * ARABIC] – Chip Shed secondary containment with oily water

Picture [SEQ Picture * ARABIC] – Chip Shed tote of oily mop water

Picture [SEQ Picture * ARABIC] – Chip Shed totes of oily mop water

Pursuant to ADEM Admin. Code r. 335-14-17-.03(4)(c)1. [40 C.F.R. § 279.22(c)(1)], containers and aboveground tanks used to store used oil at generator facilities must be labeled or marked clearly with the words “Used Oil.”

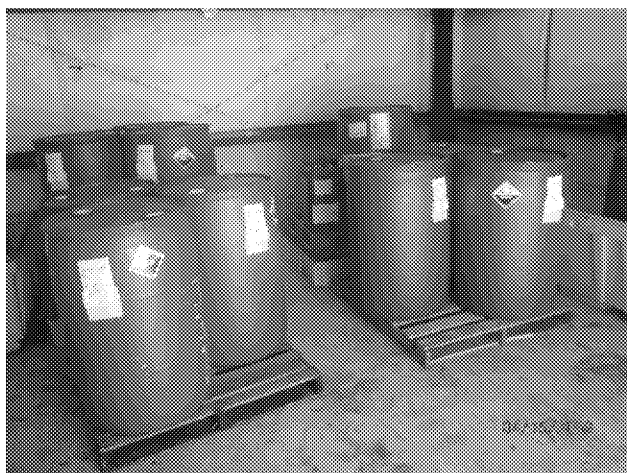
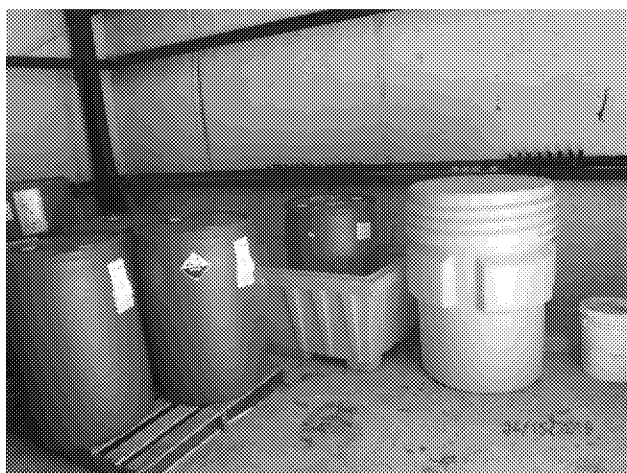
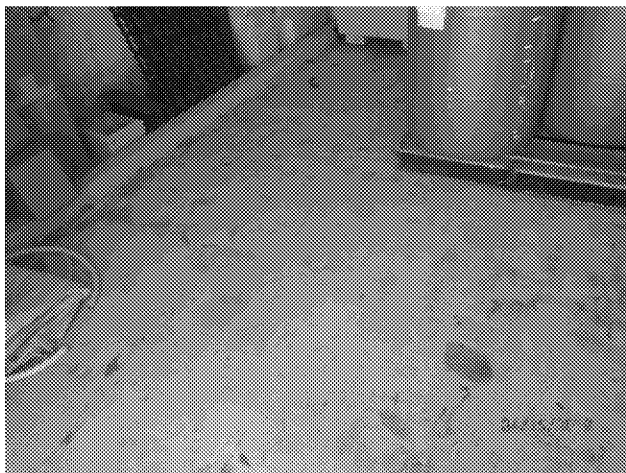
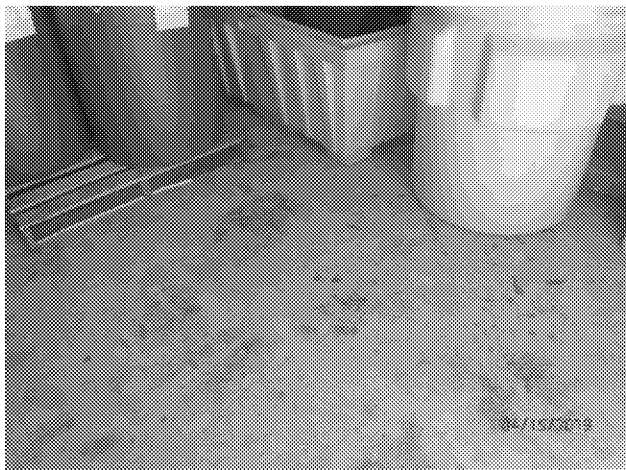
Inside the HWSA, the inspectors observed nine 55-gallon drums of spent phosphoric/sulfuric acid, yellow storage bin for chrome containers sitting on drainage grate, and the secondary containment flooring coating in poor condition (Pictures 41-49). The oldest drum was dated March 11, 2019.

Picture [SEQ Picture * ARABIC] – HWSA chrome product storage

Picture [SEQ Picture * ARABIC] – HWSA

Picture [SEQ Picture * ARABIC] – HWSA label

Picture [SEQ Picture * ARABIC] – HWSA secondary containment floor

Pursuant to ADEM Admin. Code r. 335-14-6-.02(6)(c). [40 C.F.R. 265.15(c)], the generator must remedy any deterioration or malfunction of equipment or structures which the inspection reveals on a schedule which ensures that the problem does not lead to an environmental or human health hazard. Where a hazard is imminent or has already occurred, remedial action must be taken immediately.

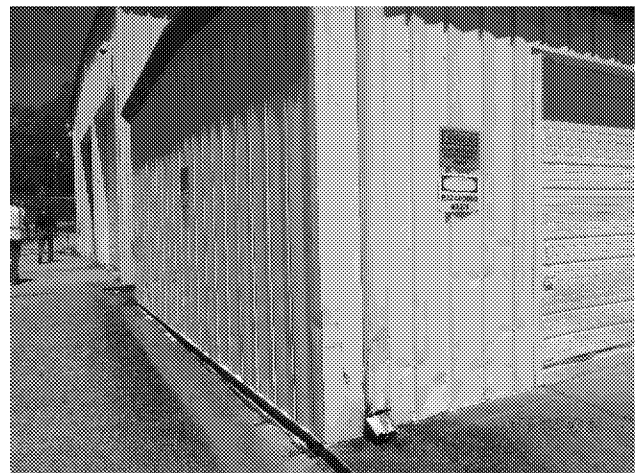
The less than 90-day hazardous waste storage area is in a standalone building. The inspectors observed “No Smoking” signs on three sides of the building but not on the front of the building.

Picture [SEQ Picture * ARABIC] – HWSA signs – No Smoking sign missing

Pursuant to ADEM Admin. Code r. 335-14-3-.01(7)(a)1.(vi)b. [40 C.F.R. § 262.17(a)(1)(vi)(B)], which is a condition of the LQG Permit Exemption, a generator must conspicuously place “No Smoking” signs wherever there is a hazard from ignitable or reactive waste.

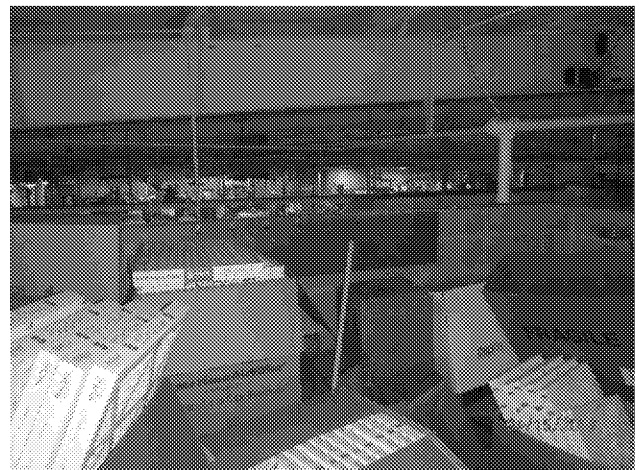
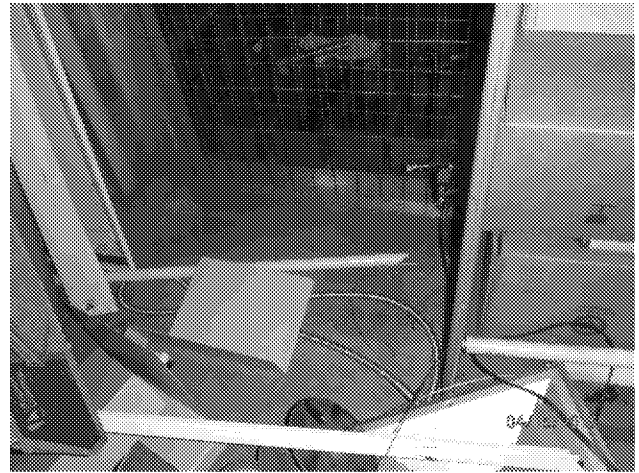
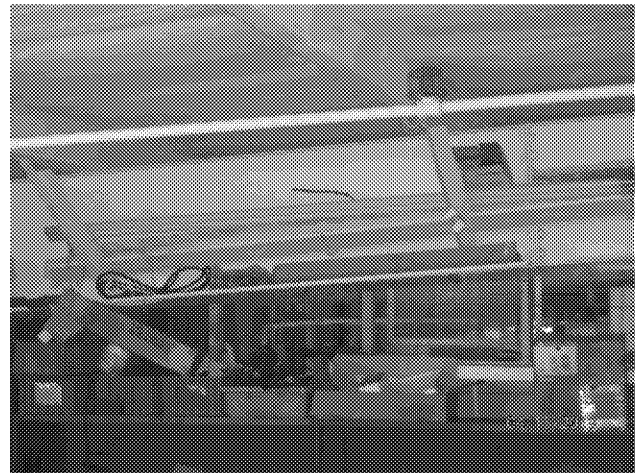
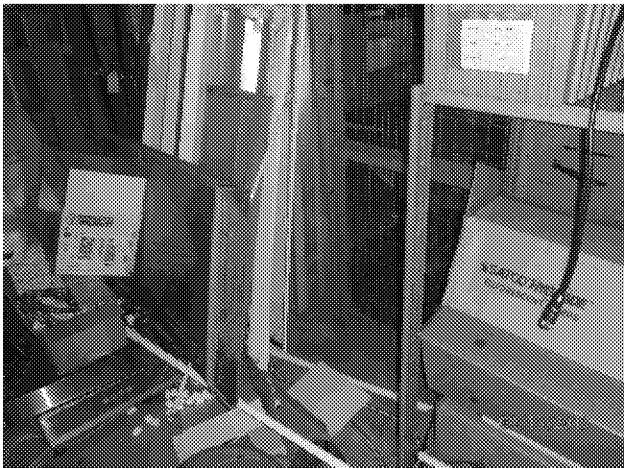
The universal waste lamps are kept in the Maintenance Loft. The inspectors observed one 4-foot spent fluorescent lamp leaning against a cardboard box, two 8-foot spent fluorescent lamps hanging in the rafters, one 4-foot spent fluorescent lamp leaning against a wall, and a broken fluorescent lamp on the floor (Pictures 50-55).

Picture [SEQ Picture * ARABIC] – Loft – uncontained UW lamp

Picture [SEQ Picture * ARABIC] – Loft – uncontained UW lamps

Picture [SEQ Picture * ARABIC] – Loft – uncontained UW lamp broken

Pursuant ADEM Admin. Code r. 335-14-11-.02(4)(d) [40 C.F.R. § 273.13(d)], a SQHUW must manage universal waste lamps in a way that prevents releases of any universal waste or component of a universal waste to the environment.

Pursuant ADEM Admin. Code r. 335-14-11-.02(4)(d)2. [40 C.F.R. § 273.13(d)(2)], a SQHUW must immediately clean up and place in a container any lamp that is broken and must place in a container any lamp that shows evidence of breakage, leakage, or damage that could cause the release of mercury or other hazardous constituents to the environment.

Pursuant to ADEM Admin. Code r. 335-14-11-.02(5)(e) [40 C.F.R. § 273.14(e)], a SQHUW must label or mark each lamp or container of lamps clearly with one of the following phrases: “Universal Waste-Lamp(s),” or “Waste Lamp(s),” or “Used Lamps.”

Pursuant to ADEM Admin. Code r. 335-14-11-.02(6)(a) and (c) [40 C.F.R. § 273.15(a) and (c)], a SQHUW may accumulate universal waste no longer than one year and must to be able to demonstrate the length of time that the universal waste has accumulated from the date that it became a waste or was received.
